Landslide Rapid Impact Assessment at Hydro Dam via THyCAS and UAS

The TNB Hydro Catchment Area Surveillance (THyCAS) is a web-based geographic information system (GIS) used to monitor hydropower dam catchment areas in Peninsular Malaysia. It can also be used for landslide rapid impact assessment by monitoring the surrounding landslide area. However, during the rainy season, satellite images are unable to provide the information required by users due to full cloud cover. Therefore, an Unmanned Aircraft System (UAS) is used to provide the data required by THyCAS by mapping the surrounding area affected by landslides and uploading the processed data in THyCAS. Thus, the user can get the required information regarding the landslide incident. Furthermore, with UAS Full Motion Video (FMV) data, the location of the collapsed power transmission towers can be acquired. In addition, any information on land changes that could jeopardise the surrounding dam area is gathered. Therefore, with the information from the rapid impact assessment provided by THyCAS and UAS data, a preliminary risk assessment plan can be established and implemented by the relevant parties. The results obtained from th

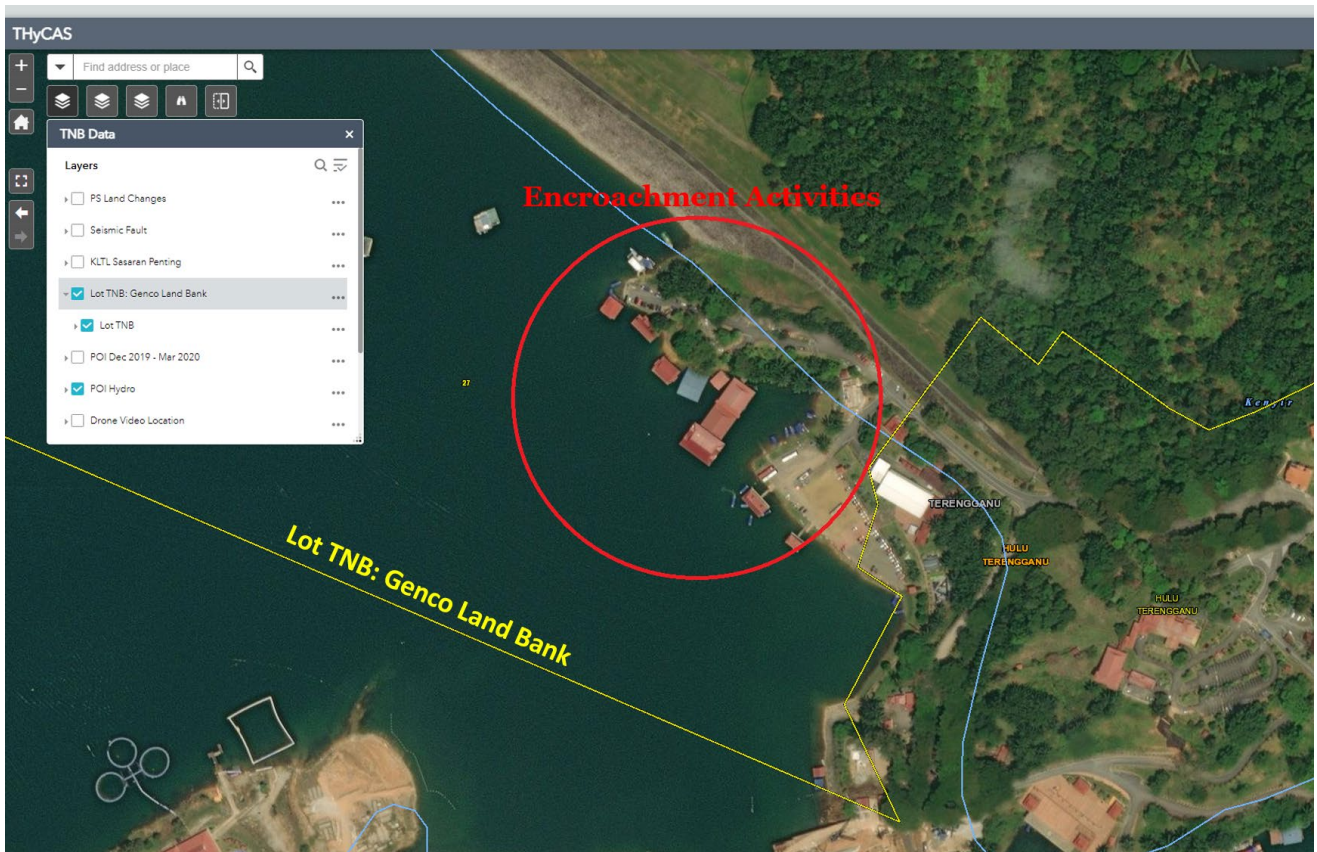
Figure 2. Encroachment at the Kenyir dam

encroachment at the TNB dam area (Figure 2) and to resolve flood issues with stakeholders by using an elevation profile analysis (Figure 3).

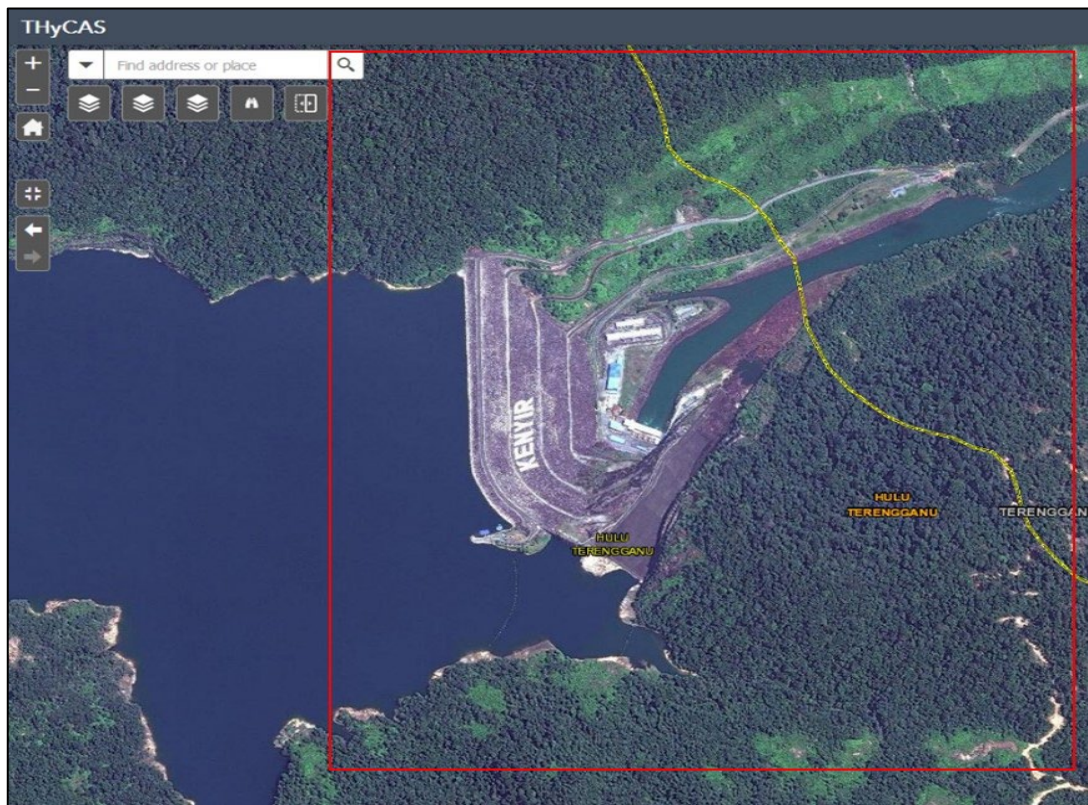
Figure 8. The total area covered by UAS mapping

The estimated area covered by UAS mapping for the Kenyir Dam (Figure 8) was around 2.31 km² (230.6 Hectares). According to the uploaded orthophoto image in THyCAS, the area affected by the landslide was identified by comparing the UAS orthophoto with the satellite image before the landslide incident. The primary access route to the power station (Figure 9) was affected by the landslide based on a visual interpretation of the surrounding dam area. For instance, landslides have rendered the major access road that leads to the power station impassable and completely submerged. Therefore, this information was provided to the relevant authorities to aid in the repair of the dam's main entrance.
