# Damages Scale as a Supporting Tool for Windstorm Early Warning System in Malaysia

It is a fact that windstorm is a natural disaster that can create enormous damages. Thus, the article aims to serve as a guideline in establishing the damages scale as the supporting tool in the windstorm disaster management. The purpose of the scale is to mitigate impacts of windstorm via early warning system, so that local authorities and public at the affected area are able to know the worst-case scenario if windstorm occurred and could make early preparation in minimising the impacts. The damage scale is established based on the current damage criteria as an early warning of windstorm occurrences was adopted from the damages scale which was established outside Malaysia. On the other hand, there is no damages scale originally established in the country. In order to establish this supporting tool, 51 windstorm occurrences in year 2012 to 2016 from 6 districts in Peninsular Malaysia were selected as a study case and 246 damages were assessed. Besides windstorm damages, gust speed, wind direction, rainfall and radar images as raw data, the study also acquires local conditions wind multiplier map co

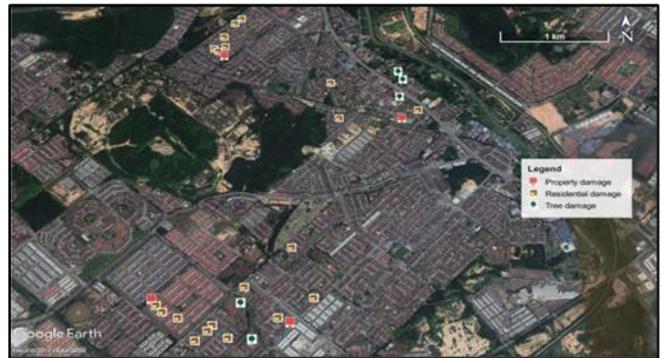
Figure 2. Location of damages at affected areas according to three major groups (building, property, and tree) in Google Earth map during windstorm occurrences on April 14th, 2012, at Johor Bahru district (study case: JB42)

All the damages identified will be coordinated in the Google Earth Pro map. The damages also will be categorised according to the types of damages which are effects to building, structures, property, or tree because existing damage scales categorised physical damage into the three major groups namely building and structures, property, or tree (Figure 2). Moreover, this has liaised with major groups of damage indicators in EF-scale.
